SCIENCE FOR THE CONSERVATION-RESTORATION
OF CULTURAL HERITAGE

*“The roman nails of Zwammerdam ships: a proposal for
provenance, conservation and technological level”*

Tesi di laurea in “Ancient metallurgy”

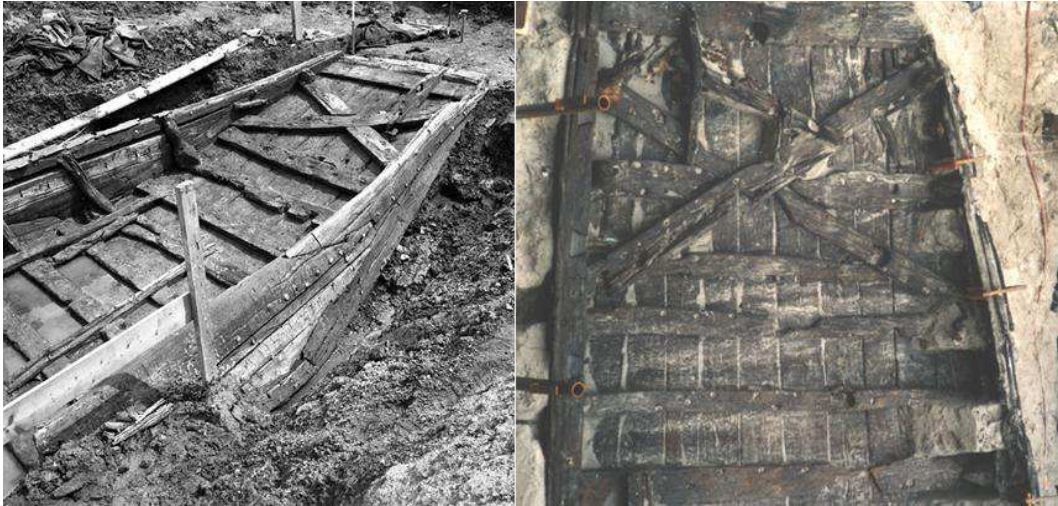
Figure 2 Zwammerdam 6 (left) and Woerden 7 (right) (photo's IPP and Y.Vorst).

Woerden in 2003 and the ship resembles the Zwammerdam 6 very closely in construction. Some of their shared characteristics are (see fig. 3):

Alongside these visible similarities, both ships date to the same year (163 AD) and both their timber provenance⁶ and the way oak timbers originating from different areas are used within the vessels are very similar. A hypothesis within the ship research project⁷ is that these vessels were built (possibly together) at the same shipyard.

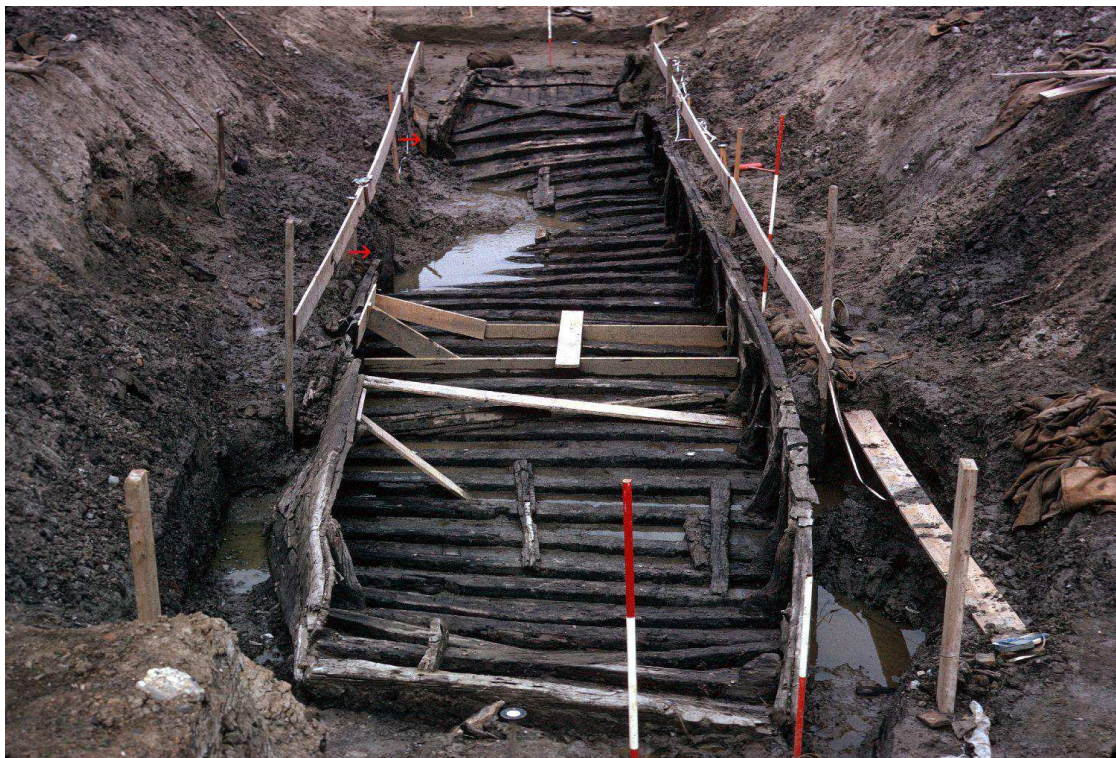
Figure 5 Zwammerdam 6 during excavation. The red arrows mark the cut-out section on portside (photo IPP)
